WOOD DESTROYING PESTS AND ORGANISMS INSPECTION REPORT

Building No. 758	Street Haverhill Dr.	City Sunnyvale	Zip 94087	Date of Inspection 07/21/10	Number of Pages 8
Remnant Termite Control Company 499 Salmar Ave. #G Campbell CA 95008 Tel 408-374-7100 Fax 408-374-7101 remnanttermite@yahoo.com				Report # : 12432 Registration # : PR3771 Escrow # : <input type="checkbox"/> CORRECTED REPORT	
Ordered by: JENNY HUH U.S.NETWORK REALTY 3334 EL CAMINO REAL SANTA CLARA CA 95051		Property Owner and/or Party of Interest: JENNY HUH/Agent 758 Haverhill Dr. Sunnyvale CA 94087		Report sent to: JENNY HUH U.S.NETWORK REALTY 3334 EL CAMINO REAL SANTA CLARA CA 95051	
COMPLETE REPORT <input checked="" type="checkbox"/> LIMITED REPORT <input type="checkbox"/> SUPPLEMENTAL REPORT <input type="checkbox"/> REINSPECTION REPORT <input type="checkbox"/>					
GENERAL DESCRIPTION: 1 STORY, 1 FAMILY, WOOD FRAME, STUCCO/WOOD EXTERIOR				Inspection Tag Posted: SUBAREA Other Tags Posted:

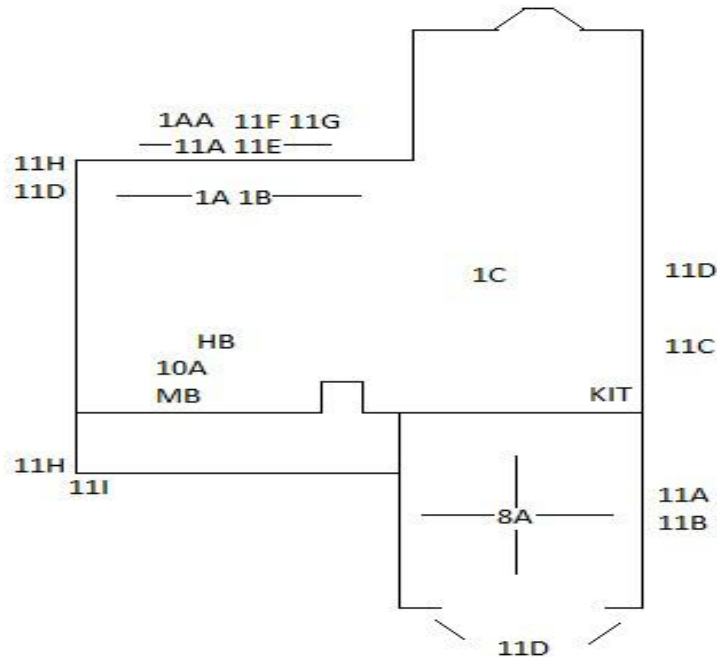
Diagram Not To Scale

01A - FINDING; The rim joist at rear has been damaged by fungus where indicated on the diagram.

11A - FINDING; Fungus damage was noted to the rafters as indicated on the diagram.

11B - FINDING; Fungus damage was noted to the fascia as indicated on the diagram.

11C - FINDING; Minor crack was noted in the exterior stucco as indicated on the diagram.

11E - FINDING; The rafter at rear has been damaged by termites where indicated on the diagram.

11H - FINDING; Fungus damage was noted to the barge rafter as indicated on the diagram.

11I - FINDING; Fungus damage was noted to the roof eaves as indicated on the diagram.

RECOMMENDATION; Remove and replace and/or reinforce all damaged wood members. Treat with fungicide if necessary. If any damage is found to extend into any enclosed areas, a supplemental report and bid will be issued. SECTION 1

RECOMMENDATION; Remove and replace the damaged wood members to correct this condition. This bid includes replacement of roof covering where disturbed by our repairs. The guarantees on the roof covering are limited to the areas where the work was performed. SECTION 1

RECOMMENDATION; The owner is to seal these areas and maintain the exterior paint. SECTION 2
