Inspection Report

Property Address:
4035 Crandall CIR
Santa Clara CA 95054

Anderson Home Inspector LLC

Date: 3/11/2010	Time: 10:30 AM	Report ID: 031110CRSA
Property: 4035 Crandall CIR Santa Clara CA 95054	Customer: Jenny Lee	Real Estate Professional: John Choi US Network Realty

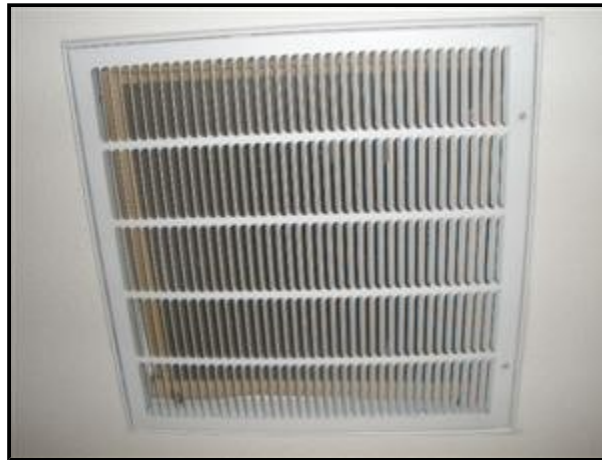
5.2 Picture 1

The furnace air filter is located inside the return air register on the upstairs hallway ceiling (Picture 1). The filter appears to be dirty. Recommend changing the air filter to improve air quality.

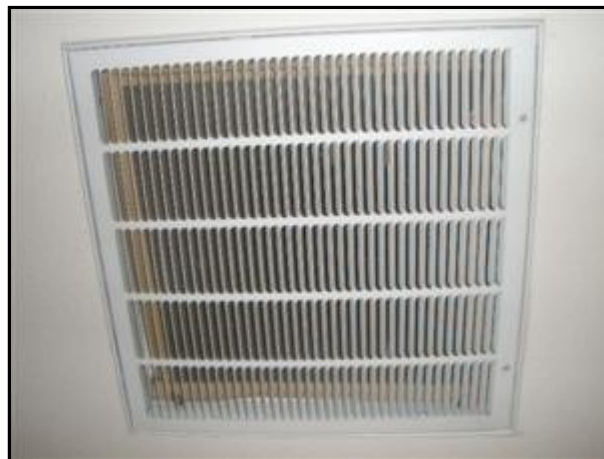
5.2 Picture 1

The furnace air filter is located inside the return air register on the upstairs hallway ceiling (Picture 1). The filter appears to be dirty. Recommend changing the air filter to improve air quality.
