WOOD DESTROYING PESTS AND ORGANISMS INSPECTION REPORT

Building No. 1160	Street Bunce Ct.	City San Jose	Zip 95132	Date of Inspection 08/09/10	Number of Pages 7
Remnant Termite Control Company 499 Salmar Ave. #G Campbell CA 95008 Tel 408-374-7100 Fax 408-374-7101 remnanttermite@yahoo.com				Report # : 12513 Registration # : PR3771 Escrow # : <input type="checkbox"/> CORRECTED REPORT	
Ordered by: John Choi U.S. NETWORK		Property Owner and/or Party of Interest: John Choi/agent 1160 Bunce Ct. San Jose CA 95132		Report sent to: John Choi U.S. NETWORK	
COMPLETE REPORT <input checked="" type="checkbox"/> LIMITED REPORT <input type="checkbox"/> SUPPLEMENTAL REPORT <input type="checkbox"/> REINSPECTION REPORT <input type="checkbox"/>					
GENERAL DESCRIPTION: TRI LEVEL, 1 FAMILY, WOOD FRAME, WOOD/STUCCO EXTERIOR, TILE ROOF				Inspection Tag Posted: SUBAREA Other Tags Posted:	
An inspection has been made of the structure(s) shown on the diagram in accordance with the Structural Pest Control Act. Detached porches, detached steps, detached decks and any other structures not on the diagram were not inspected.

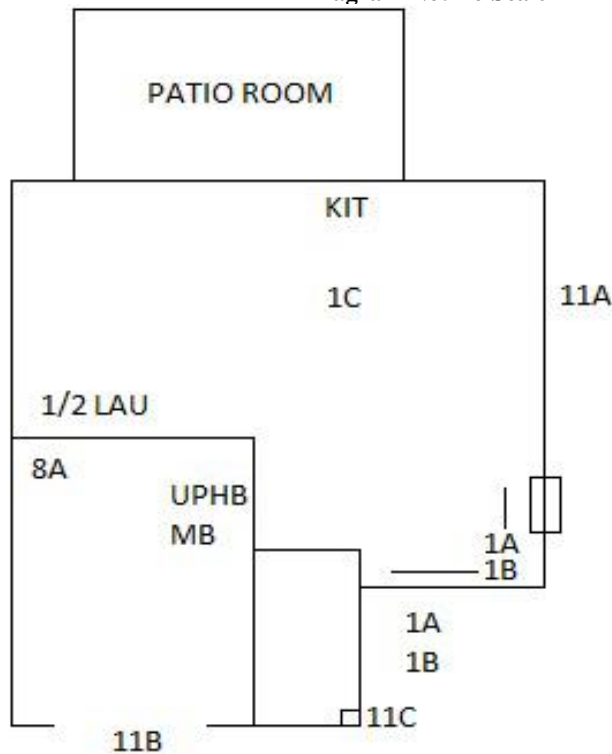
Diagram Not To Scale

01A - FINDING; Infestation of Drywood Termites was noted at subarea/exterior.

08A - FINDING; The side garage door has been damaged by fungus.

11A - FINDING; Minor crack was noted in the exterior stucco as indicated on the diagram.

11B - FINDING; The beam end at front has been damaged by fungus where indicated on the diagram.

11C - FINDING; The column trim and siding has been damaged by fungus and termites where indicated on the diagram.

RECOMMENDATION; Due to the nature of these infestations, it will be necessary to seal the entire structure and fumigate it with Vikane(sulfuryl floride), using Chloropicrin as a warning agent. The entire structure must be vacant for at least 72 hours for this process. It is the owner's responsibility to have the utilities turned back on when the fumigation is complete. We will use all due caution in our operation; however, we assume no liability for damage to the roof covering, solar panels, TV antennae, or plants adjacent to the structure. The occupants must sign the Occupant's Fumigation Notice and comply with all of the instructions.

RECOMMENDATION; Supply and install a new door. We intend to reuse the existing hardware. SECTION 1

RECOMMENDATION; The owner is to seal these areas and maintain the exterior paint. SECTION 2

RECOMMENDATION; Remove and replace and/or reinforce all damaged wood members. Treat with fungicide if necessary. If any damage is found to extend into any enclosed areas, a supplemental report and bid will be issued. SECTION 1

RECOMMENDATION; Remove and replace and/or reinforce all damaged wood members. Treat with fungicide if necessary. If any damage is found to

extend into any enclosed areas, a supplemental report and bid will be issued. SECTION 1
